Manhole Inspection Summary

Manhole # S55M__034MH

Location Address: **1001 S HIGHLAND AV**

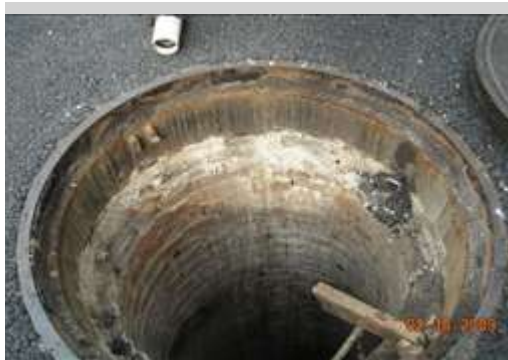
MISC.

Subject To Ponding: **Sheeting**

INFLOW EVIDENCE FROM SHEETING

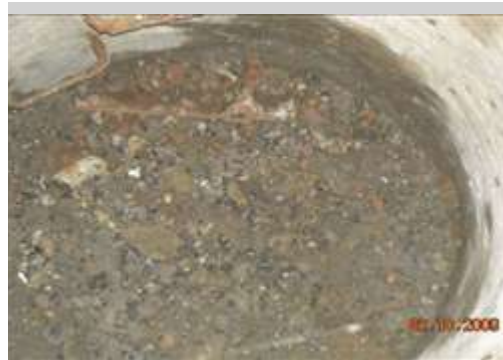
Defect 4

Condition: ☐ Sound ☐ Cracked ☐ Root Intrusion ☐ Deteriorated ☐ Leaks ☒ **Debris**

DEBRIS IN TERMINAL CHANNEL

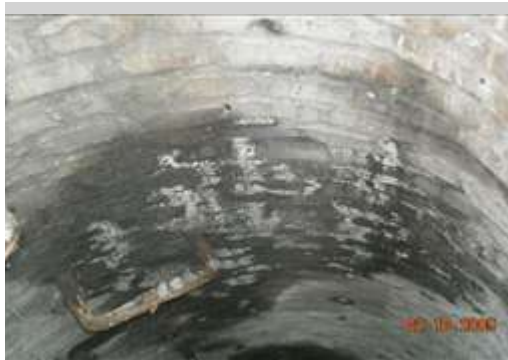
Defect 3

Infiltration: ☐ None ☐ Joint ☐ Cracks ☐ Mortar ☐ Roots ☒ **Wall**

INFILTRATION @ CORBEL WALL

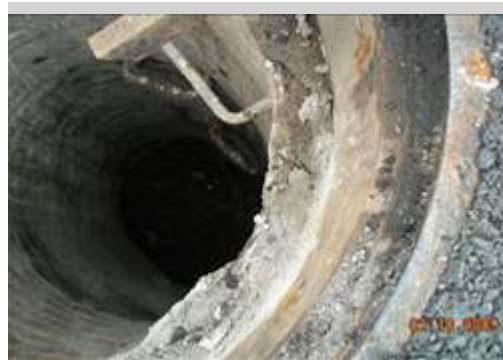
Defect 2

Offset: **2.5** (in.)

FRAME OFFSET

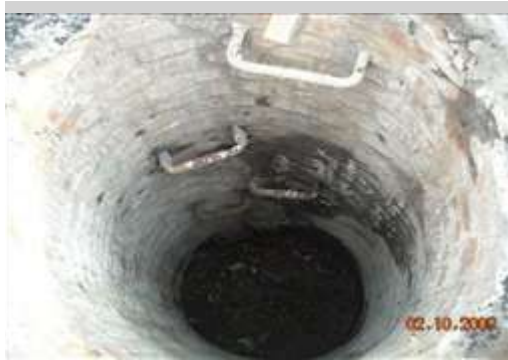
Defect 1

Count: **6** Missing: **0** ☒ **Corroded**

CORRODED STEPS

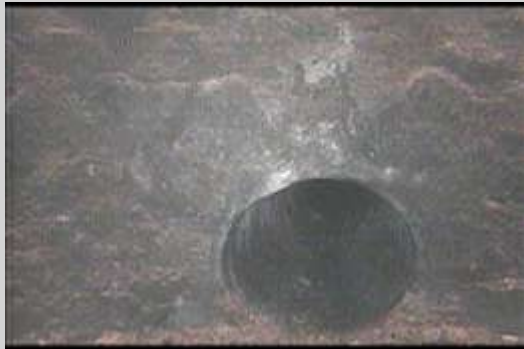
12 O'Clock Outflow

8 in. Circular Gravity Sewer
Pipe Out @ 12 O'Clock

Infiltration: **None** Pipe Seal Cond: **Sound**
